# Manhole Inspection Summary

Manhole # S43GG\_050MH

**Inspection** ☐ Is Incomplete Rating: **3) Fair**

Insp Date: **3/22/10 11:11 AM**

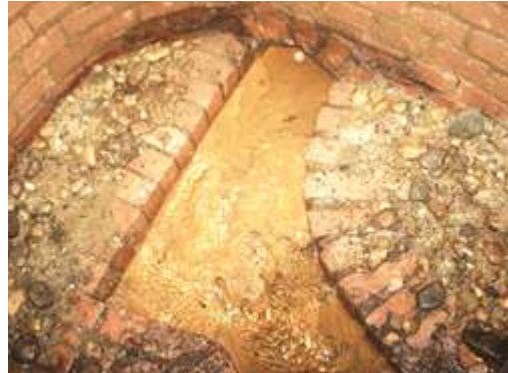
Defect 4

**Surcharge** ☐ Evidence Of Surcharge Depth: (ft.) ☒ **Active Surcharge Present**

Active surcharge.

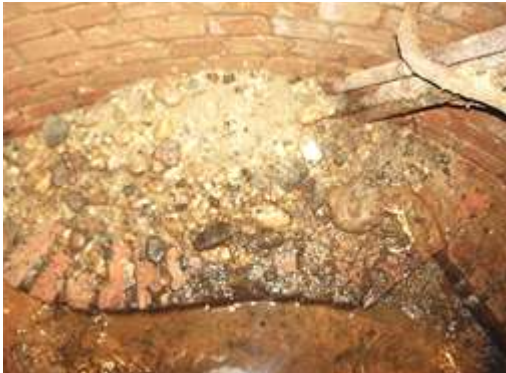
Defect 3

Condition: ☐ Sound ☐ Cracked ☐ Root Intrusion ☐ Deteriorated ☐ Leaks ☒ **Debris**

debris

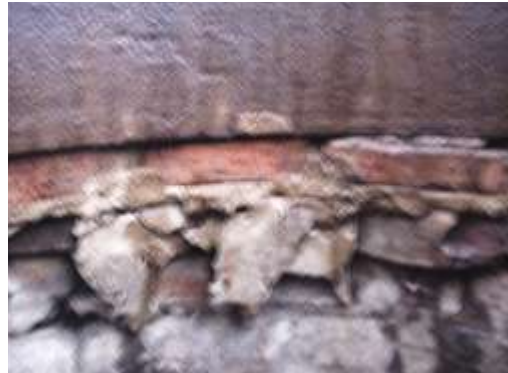
Defect 2

Condition: ☐ Sound ☐ Cracked ☐ Root Intrusion ☐ Deteriorated ☐ Leaks ☒ **Debris**

debris

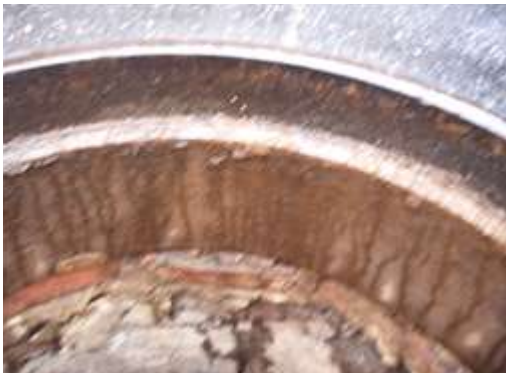
Defect 1

Condition: ☐ Sound ☐ Cracked ☐ Root Intrusion ☒ **Loose Brick** ☒ **Deteriorated**

loose bricks

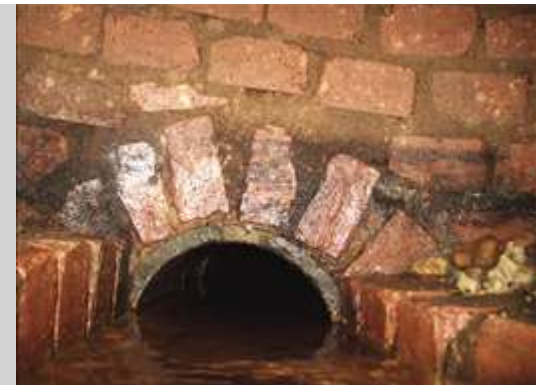
8 in. Circular Gravity Sewer  
Pipe In @ 6 O'Clock

Pipe Height: **12** (in.) Rod and Bar (Angled)  
Pipe Material: **Clay** ☐ Pipe Lined  
Invert Depth: **12.17** (ft.) Flow Characteristics: **Slow**  
Deposits: ☐ None ☒ Mud ☒ Gravy ☒ Debris ☐ Grease  
Silt Depth: **4** (in.) Deposits Extent: **Medium**  
Infiltration: **None** Pipe Seal Cond: **Sound**
